HO-1021

Newton-Earp House

6084 Old Washington Boulevard, Elkridge

Inventory No. HO-1021

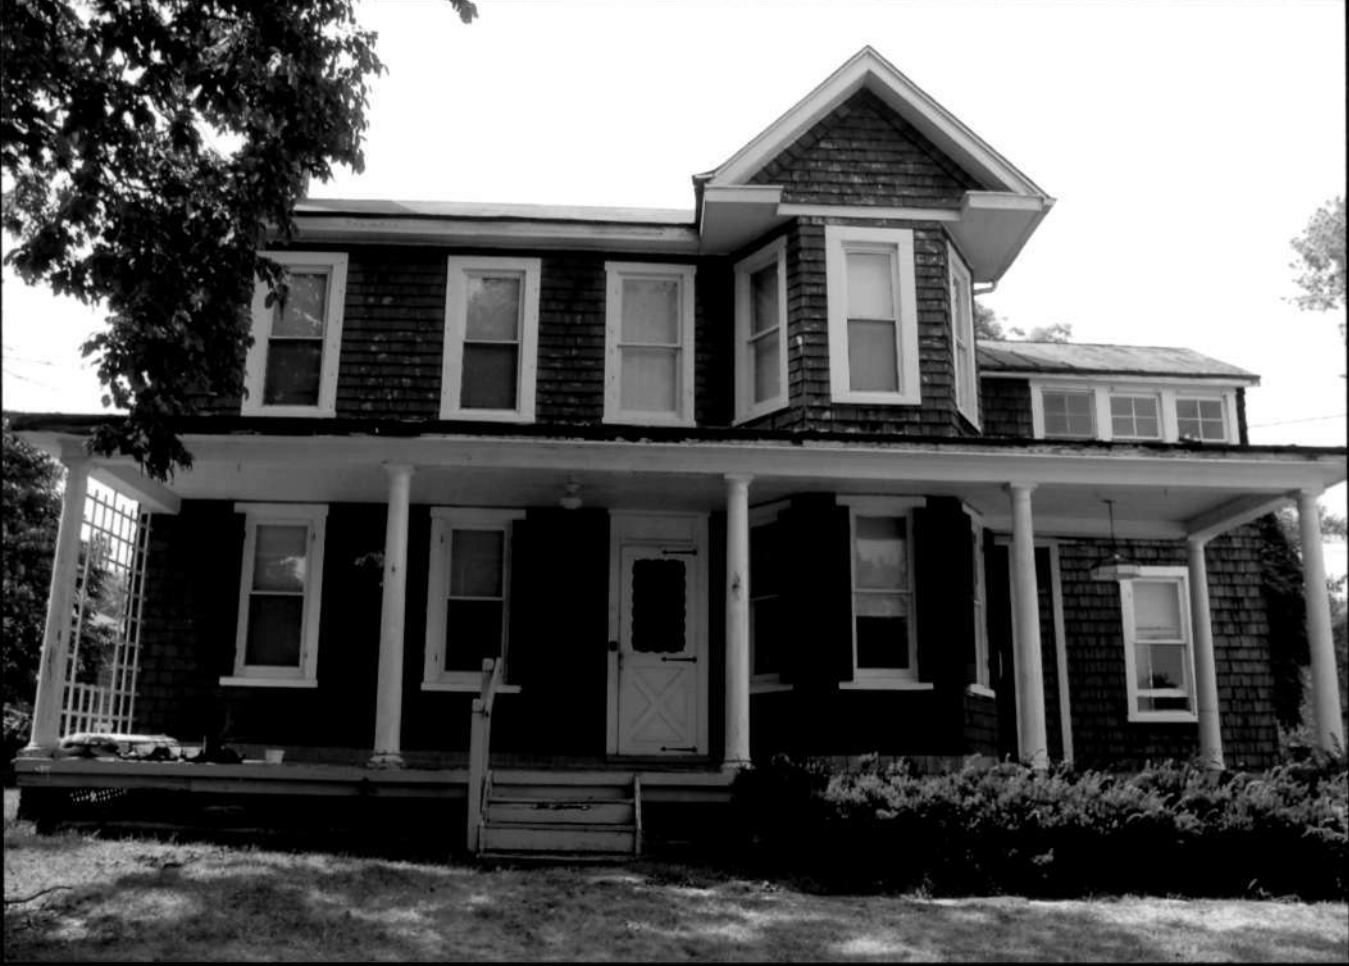
HO-1021
Newton-Earp House
6084 Old Washington Blvd.
Howard County, Maryland
Ken Short
2010-07-06
MD SHPO
House, southeast elevation
1 of 12

HO-1021_2010-07-06_01
House, southeast elevation

The Newton-Earp House is a two-story, three-bay by one-bay frame structure with wood shingles, a rubble stone foundation, and a gable roof with asphalt shingles and a northeast-southwest ridge. It has a two-story addition on the northeast that is two bays by one bay, with a one-story wing to the rear that is also two bays by one bay. This addition has a CMU foundation, wood shingles, and a gable roof with standing-seam metal and a northeast-southwest ridge on the two-story section, and with a shed roof on the one-story section. The northeast addition is set back from the plane of the main block. There is also a two-story ell on the northwest elevation of the main block that is one bay by one bay, has a rubble stone foundation, wood shingles, and a gable roof with asphalt shingles and a northwest-southeast ridge. On the southeast elevation is a one-story, five-bay hipped roof porch. The first story has a hall/parlor plan with a stair in the large entrance hall. The house is a double-pile with two rooms across the back divided by a bathroom and small vestibule, and there is one room added to the northeast end. The stair hall has a two-run dog-leg stair on the northeast wall. The house was built with guttered corner posts and re-used wooden railroad stringers.

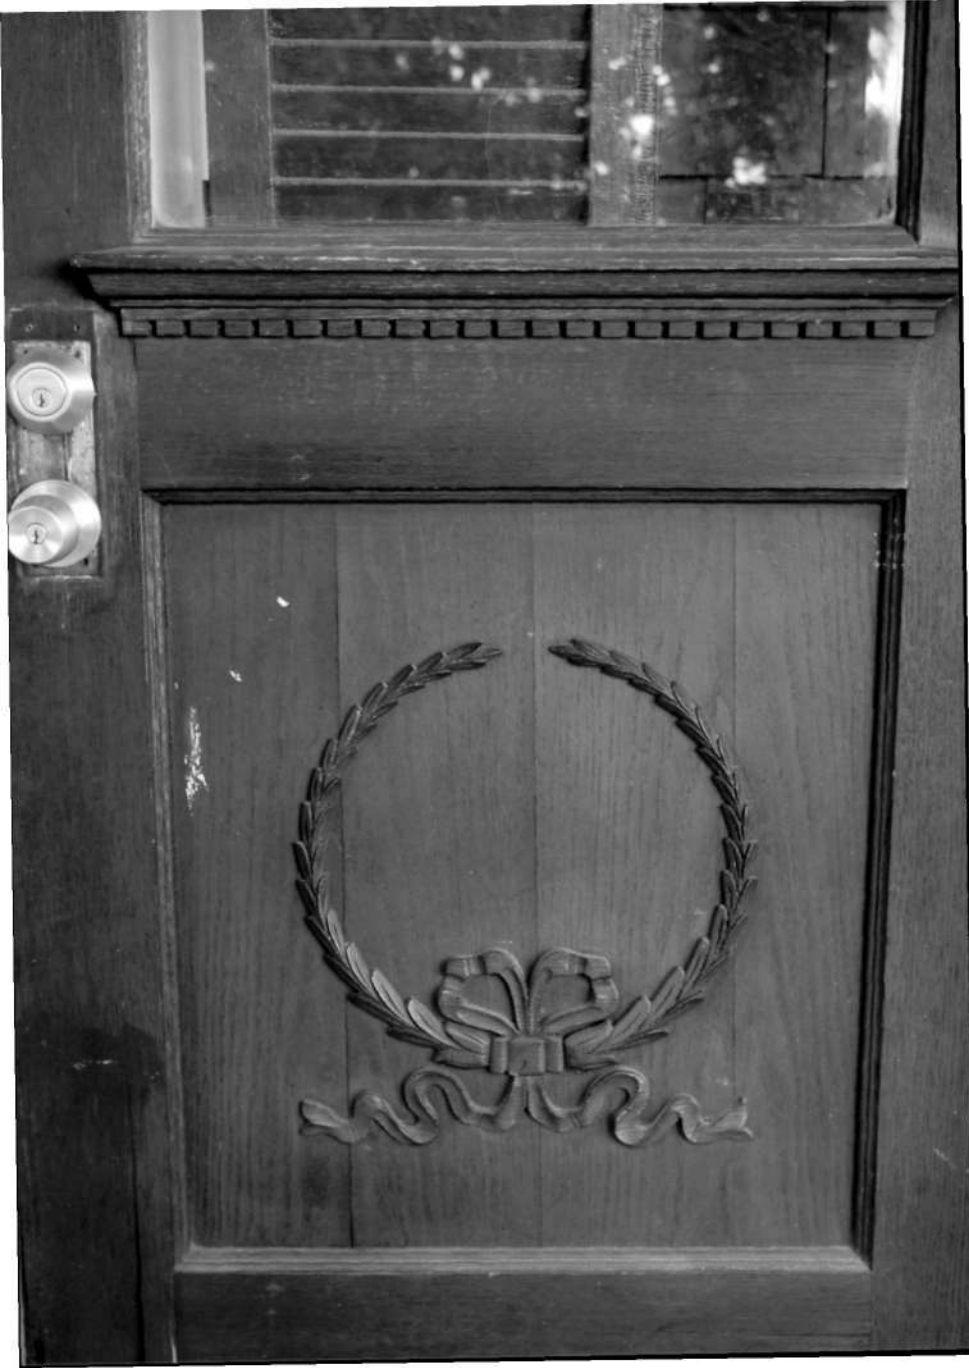
2 of 12

House, southeast elevation, front door detail

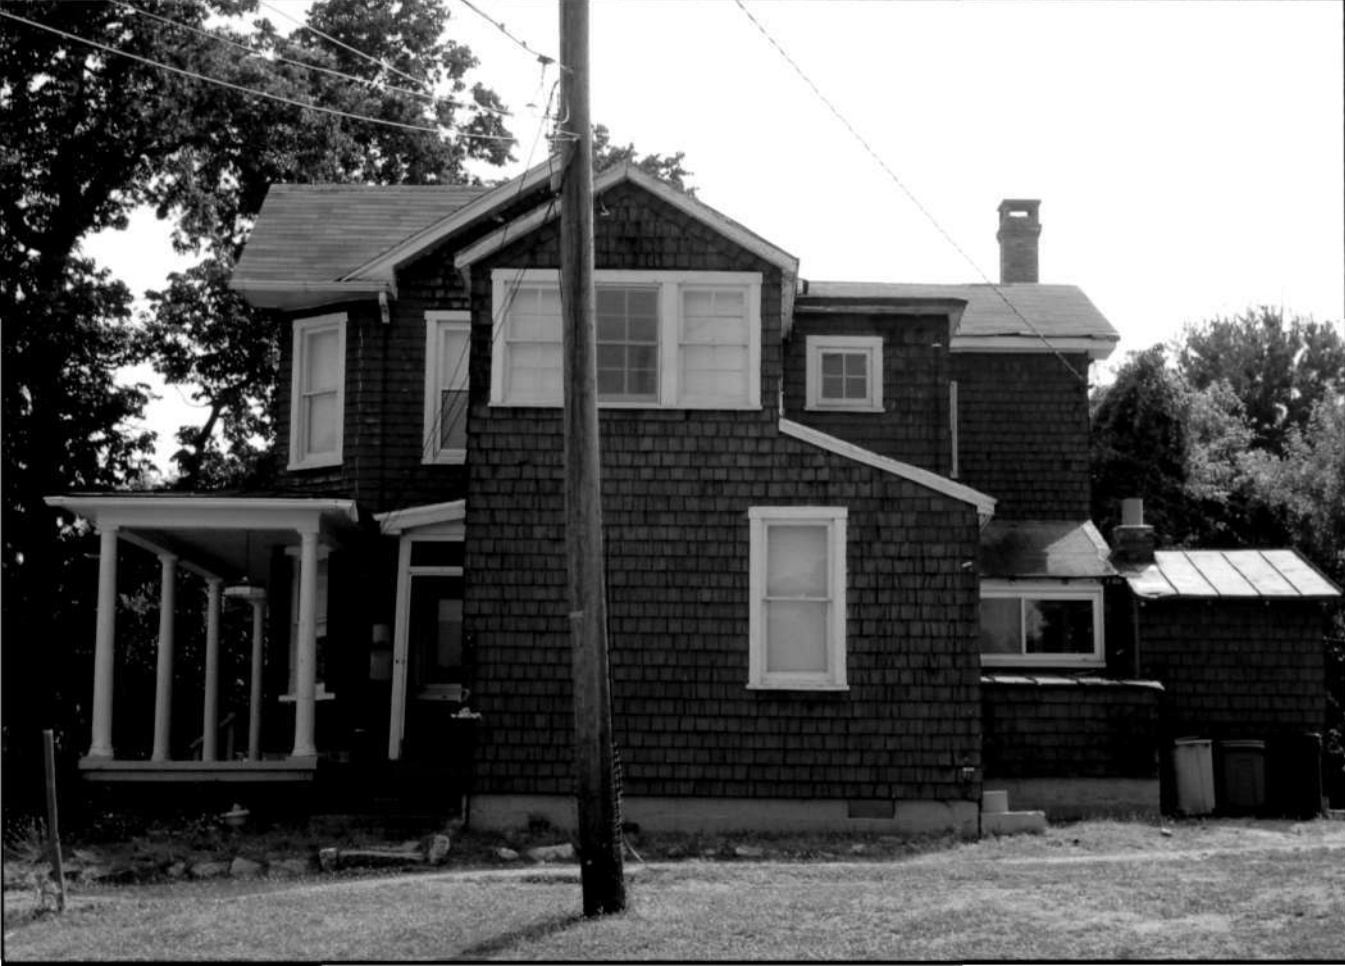
3 of 12

House, northeast elevation

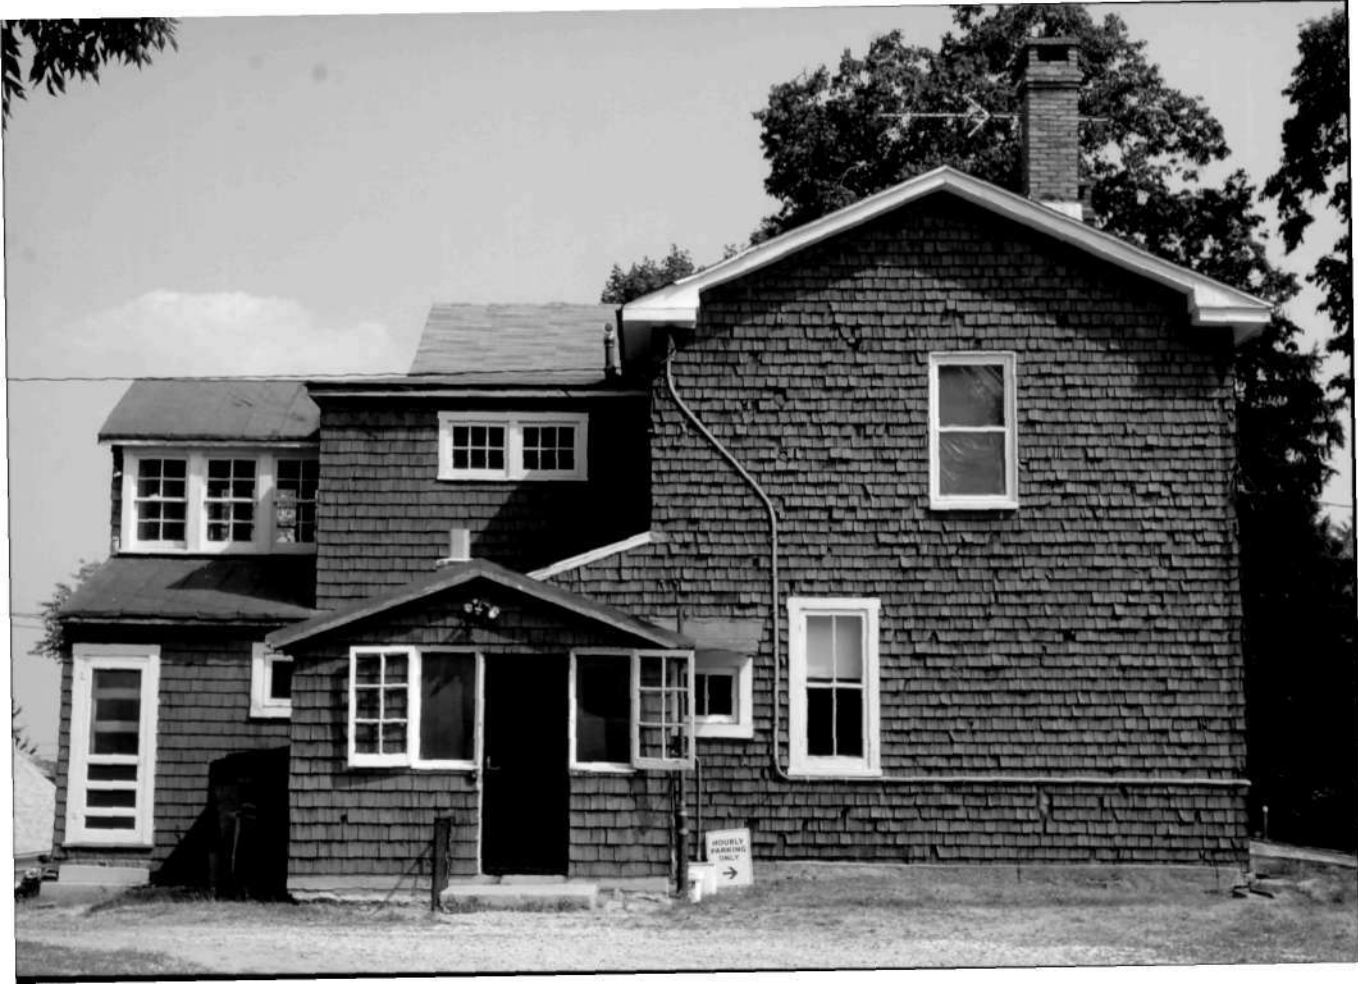
4 of 12

House, northwest elevation

The northwest elevation of the ell, on the first story, has a small window with a new two-light sliding sash at the north end and a typical one-over-one sash set north of center. The second story has a new sash in the center, and there is no opening in the gable end. The northeast elevation of the main block, east of the northeast addition, has a one-light sash with a stained glass transom on the first story. The second story has a typical one-over-one sash, and there is no opening in the gable end.

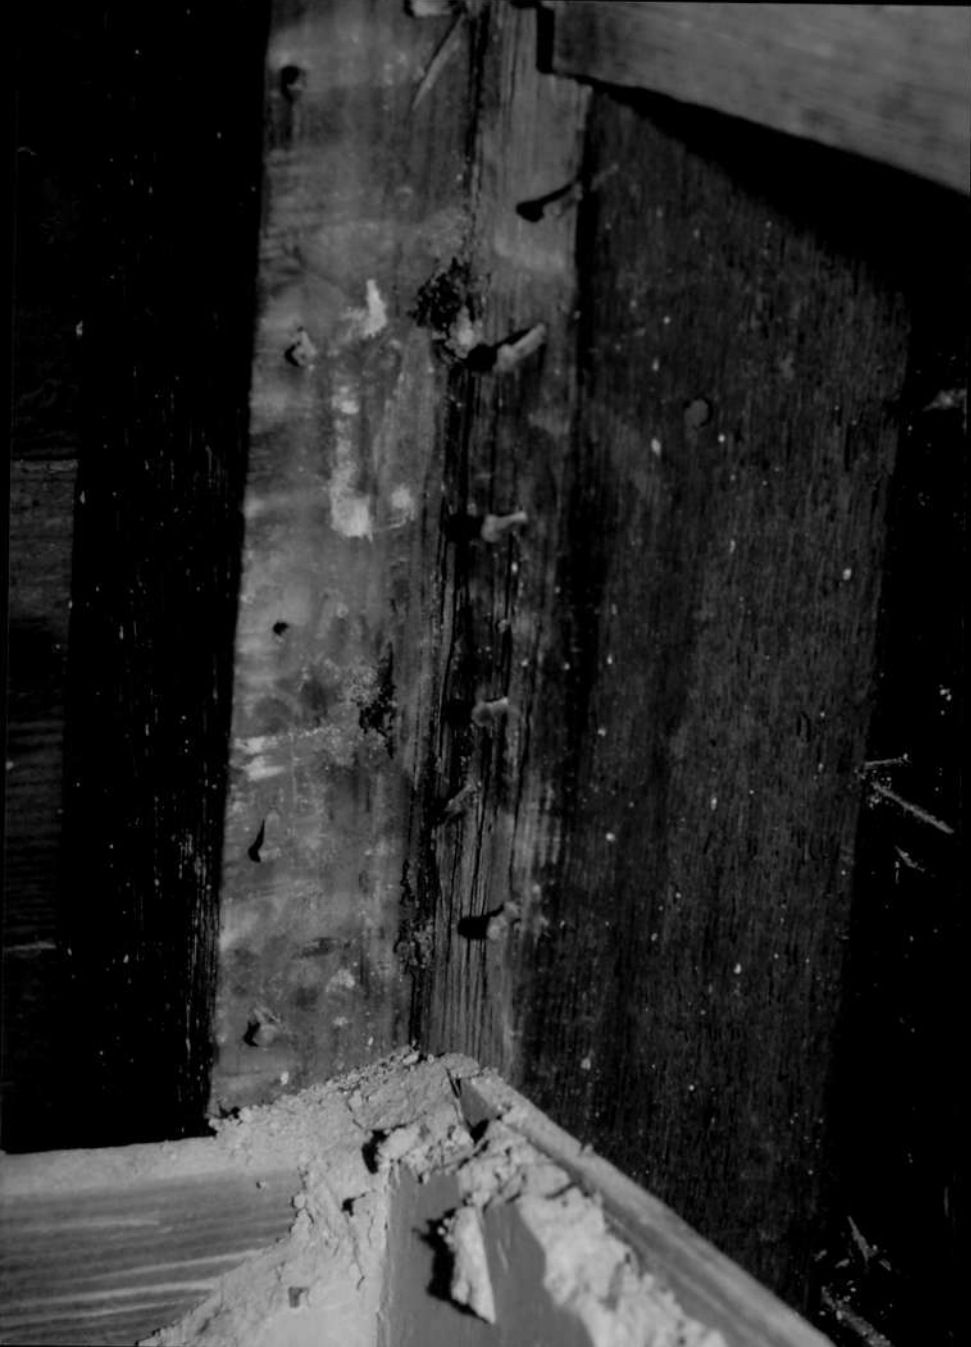
10 of 12

House, gutted corner post in south corner

The northwest and southeast walls of the stair hall were opened up, revealing that the northeastern end wall of the original house was located across the center of this room, just east of the front door. Both corner posts were guttered and had the same down braces as found on the south corner post (see below). These posts were cut back in order to be flush with the inside wall when the house was enlarged to the northeast, thus removing the guttering. The southwest, or partition, wall has riven lath with cut nails and must be original. Given the narrow width of the original east room, the house must have had a side-passage plan. The northwest wall, west of the original corner post, has a lintel with an in-filled stud below it and re-used riven lath fastened over the opening with wire nails. There is a stud in the center above the lintel, with riven lath that must be reused fastened on it with wire nails. This appears to have been a doorway, but it is set right against the post where the stairs should have been. The southwest wall has riven lath on it down low, not interrupted where a stair stringer would have been, and suggesting that the stairs were not running along the west wall. The northwest end of the ceiling is sawn

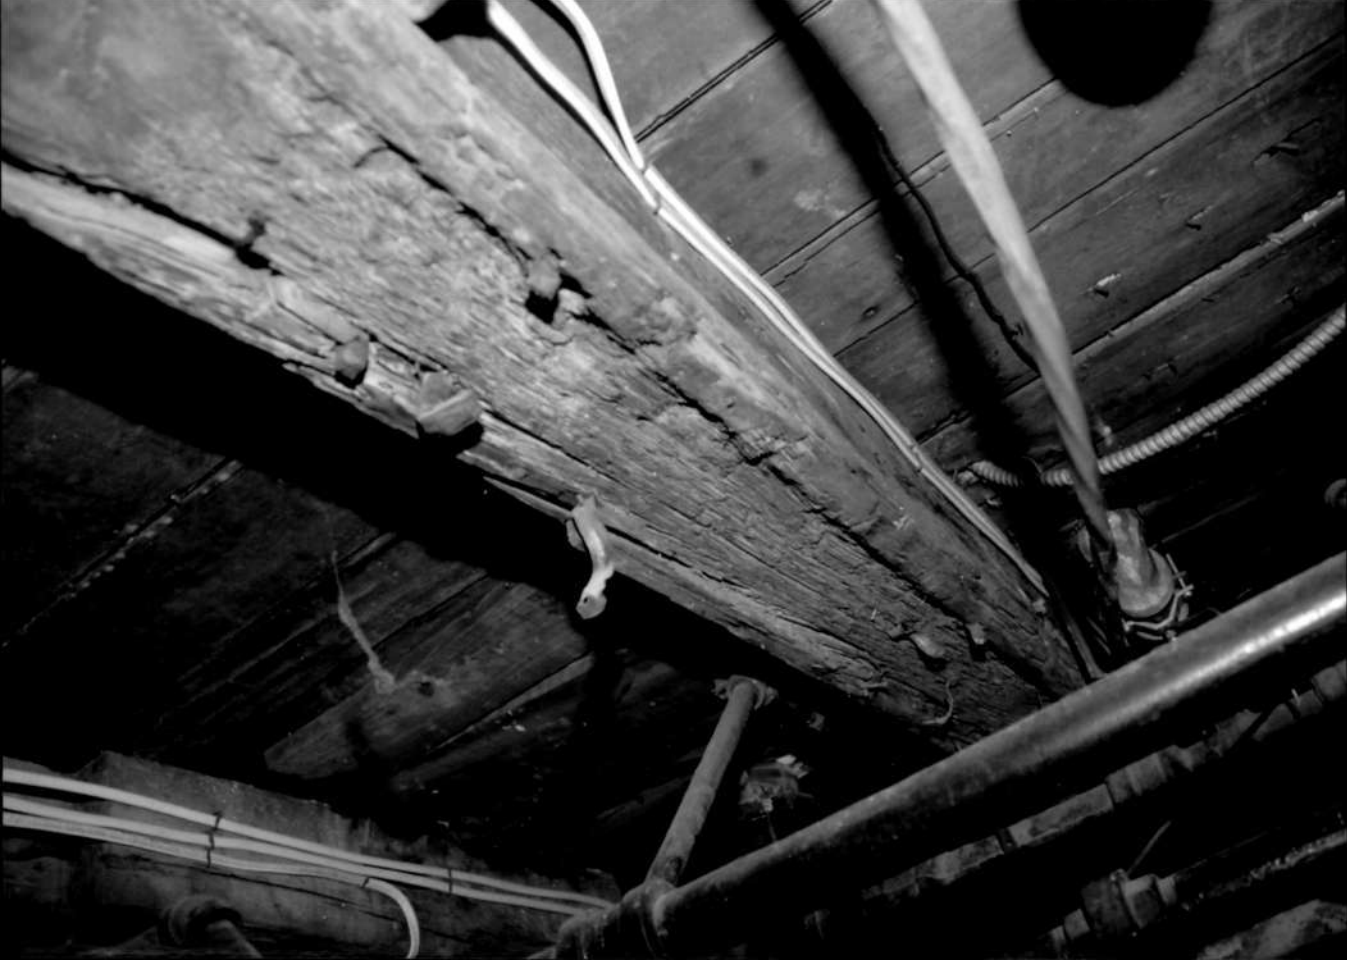
11 of 12

House, railroad tie re-used as joist, from
cellar below west room

The basement is located under the west and northwest-center rooms, or original ell, only. The walls are rubble stone, at least some of which is gabbro. There was originally an exterior entrance on the northeast elevation, at the north end. This has been closed off and an opening made on the southwest elevation. The summer beam here is a replacement that was added. The southeast sill has a mortise in it at this location where the original summer beam was. The joists run northeast-southwest. The southwestern joists are ¾-round logs that are 5 to 9 inches in diameter. The northeastern joists are re-used wooden railroad stringers that are sash-sawn and are 6 inches square. One face of each joist has a large rabbet in it that is ½ inch deep and 3¼ inches wide. There are wrought iron L-head spikes driven into the joists in this rabbet, most of them broken off, and others having simply left square holes in the wood. The spikes and holes are spaced 11 to 20 inches apart. One of these stringers has a mortise in the side of it with a peg hole, and this feature must date to its original railroad use since it is not part of the house construction. The mortise is 1½ inches by 7 inches and passes all the way through the stringer. It may have held a tie beam that would have kept the stringers in gauge. There is a down brace that laps the southeast sill and is nailed to it with cut nails. The southeast sill corner joint has a center tenon into a mortise in the southwest sill. There are several pegs near the bottom of the southeast sill, but there are no posts here and it is not clear what these pegs were intended for. The studs are 2¾ by 4 inches and have no clear connection to the southeast sill. The flooring above is tongue-and-grooved and is sawn, and is not undercut. The northwest brick chimney is sitting directly on the foundation wall.
